## **TECNICAL BULLETIN 10**

**Subject: Multi Air**

Here is a tech bulletin about the MULTI AIR made between April 2014 and August 2015.

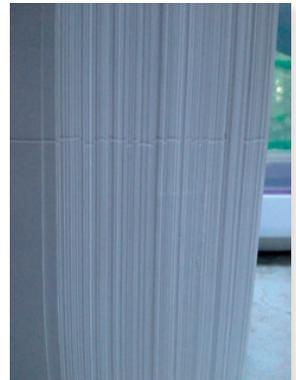
The cause of all these issues is linked to a new operator in the assembly area who over-tightened the grub screws on the suction belt infeed roller causing the roller to distort radially by up to 0.5 mm.

This would have the effect of intermittently altering the gap between the separator fingers and the suction belt and causing the above symptoms

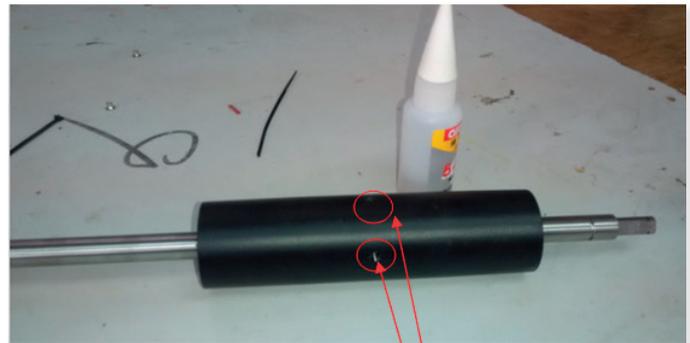
Too tight screw

- 1- Removing the front and rear side covers.
- 2- Removing the suction head top cover and suction box fixing screws.
- 3- Removing the roller drive shaft and taking out the suction box assy.
- 4- Accessing the grub screw and loosening until lightly tight on the shaft, it may be needed to use a drop of cyano glue (locktite) to ensure a good fix of roller to the shaft.
- 5- Check that there is no residual radial run -out on the roller (usually it springs
