## **TECNICAL BULLETIN 10**

**Subject: Multi Air**

Here is a tech bulletin about the MULTI AIR made between April 2014 and August 2015.

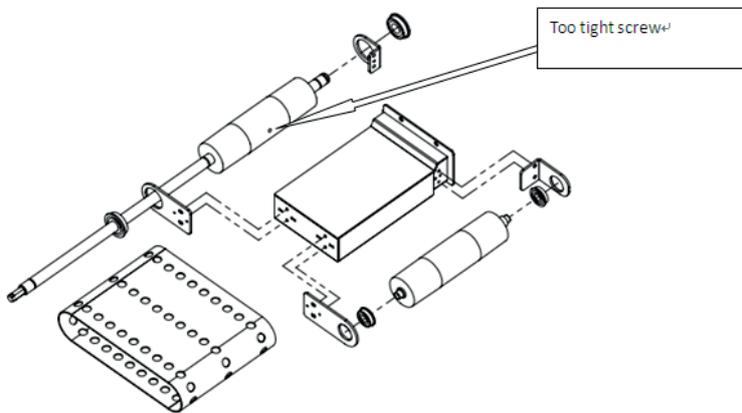
The cause of all these issues is linked to a new operator in the assembly area who over-tightened the grub screws on the suction belt infeed roller causing the roller to distort radially by up to 0.5 mm.

This would have the effect of intermittently altering the gap between the separator fingers and the suction belt and causing the above symptoms

Too tight screw

- 1- Removing the front and rear side covers.
- 2- Removing the suction head top cover and suction box fixing screws.
- 3- Removing the roller drive shaft and taking out the suction box assy.
- 4- Accessing the grub screw and loosening until lightly tight on the shaft, it may be needed to use a drop of cyano glue (locktite) to ensure a good fix of roller to the shaft.
- 5- Check that there is no residual radial run -out on the roller (usually it springs

back to its natural round shape instantly)

Refitting is the steps 5 to 1
